超快激光加工斜孔对热障涂层热循环剥落失效的影响

[摘要] 采用超快激光在电子束物理气相沉积(EB-PVD)方法制备的带热障涂层高温合金上加工 45° 斜孔, 然后对制孔试样进行热循环试验, 研究热循环前后孔的变化及孔对热障涂层热循环剥落失效的影响。初步试验结果表明, 超快激光在带热障涂层的高温合金上制孔时, 孔边缘涂层和高温合金位置处均不存在开裂和再铸层, 高温合金孔壁边缘组织没有明显变化, 仍为典型的 γ 和 γ' 组织。热循环前后小孔孔径无明显变化, 斜孔高温合金内壁由较为光洁表面变为具有明显氧化物的表面, 且随着热循环次数的增加, 高温合金孔内壁表面氧化物逐渐脱落。热障涂层在热循环 500 次后出现局部剥落现象, 超快激光加工 45° 斜孔未对热障涂层热循环剥落失效产生影响。

Effect of Ultrafast Laser Processing Inclined Holes on Thermal Barrier Coatings (TBCs) Spallation Failure

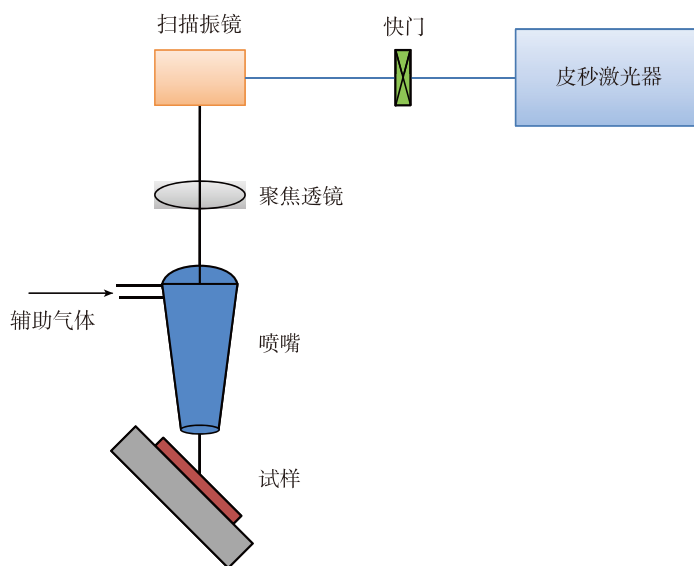
图1 超快激光加工示意图

Fig.1 Schematic diagram of ultrafast laser processing

超快激光制孔试验选取了脉冲宽度为 2.1ps 的激光扫描加工试验平台，激光最大平均功率 30W ，波长为 1030nm ，制孔过程中采用同轴辅助吹气，图 1 为超快激光加工示意图。然后将完成制孔的试样置于热循环炉内，先从室温以 $40^\circ\text{C}/\text{min}$ 速率升温到 1050°C ，保温 45min ，风冷 10min ，如此往复循环。完成试验的样品首先经过超声波清洗去除表面附着物，然后采用传统金相磨抛方式对试样进行磨抛处理，利用常用的高温合金腐蚀液对纵截面表面进行腐蚀。最后，采用 EVO-18 扫描电子显微镜对试样表面和剖面组织结构进行观察分析。

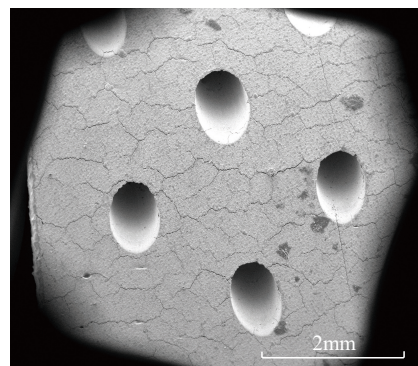
(a) 孔入口

图2 超快激光在带热障涂层高温合金试样上加工 45° 斜孔的 SEM 照片

Fig.2 SEM image of inclined holes at 45° on the superalloy sample with thermal barrier coatings (TBCs) using ultrafast laser

时间 1.5min ，预设孔径为 0.4mm ，辅助气体为氮气。图 2 (a) 为 45° 斜孔入口的 SEM 照片，结果显示， 45° 斜孔入口长轴为 1.04mm ，短轴为 0.72mm ，孔入口表面不存在飞溅物和熔化重铸物，内壁表面光洁度较好，无明显热致损伤。图 2 (b) 为 45° 斜孔纵截面的 SEM 照片，可以看出超快激光制孔孔壁边缘平缓，对孔纵截面带热障涂层 A 区域进一步放大，YSZ 陶瓷层、NiCoCrAlY 黏结层及高温合金各层之间不存在重铸层、微裂纹以及热影响区等热致缺陷^[10-11]。图 2 (c) 为 45° 斜孔边缘 B 区域高温合金位置处的 SEM 放大照片，结果显示，超快激光制孔边缘高温合金组织为 γ 和 γ' 组织，这些组织和原始高温组织无明显区别，可见超快激光制孔未对孔边缘组织产生明显影响，也不存在再铸层和微裂纹等缺陷。由带热障涂层高温合金试样超快激光制孔分析可以看出，通过对制孔工艺的优化，孔尺寸

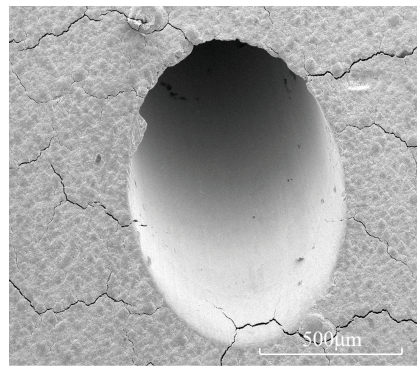
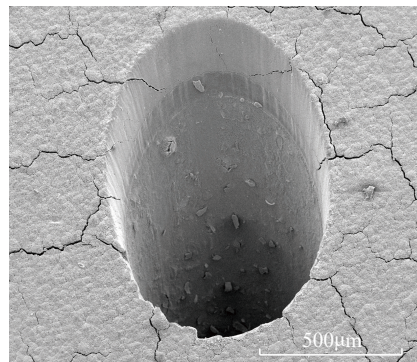
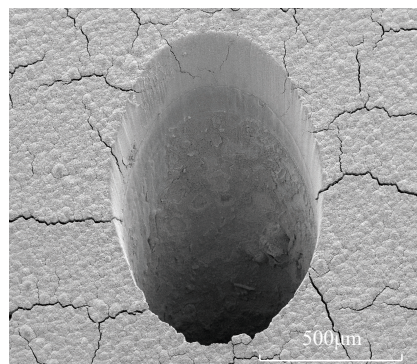
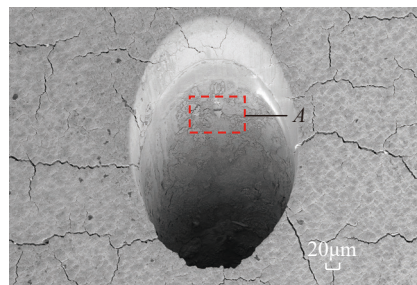
图3 超快激光加工 45° 斜孔不同热循环次数的SEM照片

(a) 0次

(b) 75次

(c) 250次

(d) 500次

Fig.3 SEM images of ultrafast laser processing inclined holes at 45° with different thermal cycling times

图3为超快激光在带热障涂层高温合金试样上加工 45° 斜孔热循环0次、75次、250次和500次后孔入口的SEM照片。结果显示, 由于YSZ陶瓷层耐热温度较高, 热循环过程中未发生明显的变化, 45° 斜孔入口孔径及形貌在整个热循环过程中没有发生明显变化。Ni基单晶高温合金在热循环过程中表面会形成不连续的 NiO 和 Cr_2O_3 , 以及少量的 Al_2O_3 , 这些氧化物不能形成保护性的氧化膜, 随着热循环的进行, 表面会生成孔洞, 造成氧化物与基体面积减小, 表面氧化物附着力降低, 使氧化膜逐渐发生剥落^[12]。从 45° 斜孔的内壁结果可以看到, 在热循环次数从0次延长到500次过程中, 孔内壁在0次时光洁度较好, 具有金属光泽, 无明显附着物; 热循环次数增大到75次时, 经EDS及表面形貌分析结果表明斜孔高温合金内壁表面具有明显的氧化物, 随着热循环次数的进一步增加, 斜孔高温合金内壁的氧化物有一定程度的脱落, 见图3(d)虚线框位置处。

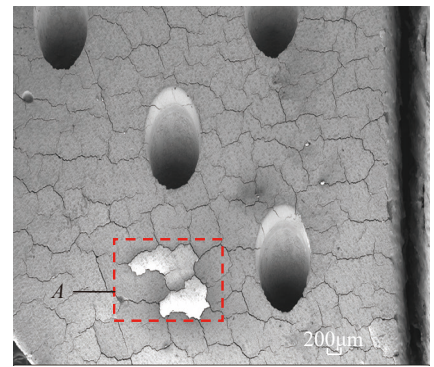
(a) 孔入口

图4 超快激光制孔试样热循环500次的SEM照片

Fig.4 SEM image of ultrafast laser drilling specimens with thermal cycling 500 times

而且随着热循环次数的增加, 涂层出现表面裂纹导致的明显剥离现象。热循环初期, 表面裂纹未导致涂层的剥离, 当热循环次数为500次时, 制孔试样表面出现衬度为白色的A区域, 见图4(a), 经分析为即将发生剥落的位置^[10], 而孔位置处未发现这种剥落, 随着热循环次数的增
